**2001 ANNUAL INSPECTION REPORT
RCRA UNITS
FORMER PROTECO FACILITY
PEÑUELAS, PUERTO RICO**

Project Number 12000-1-0141

November 13, 2001

Subject: PROTECO ID# PRD091018622
2001 Annual Inspection Report

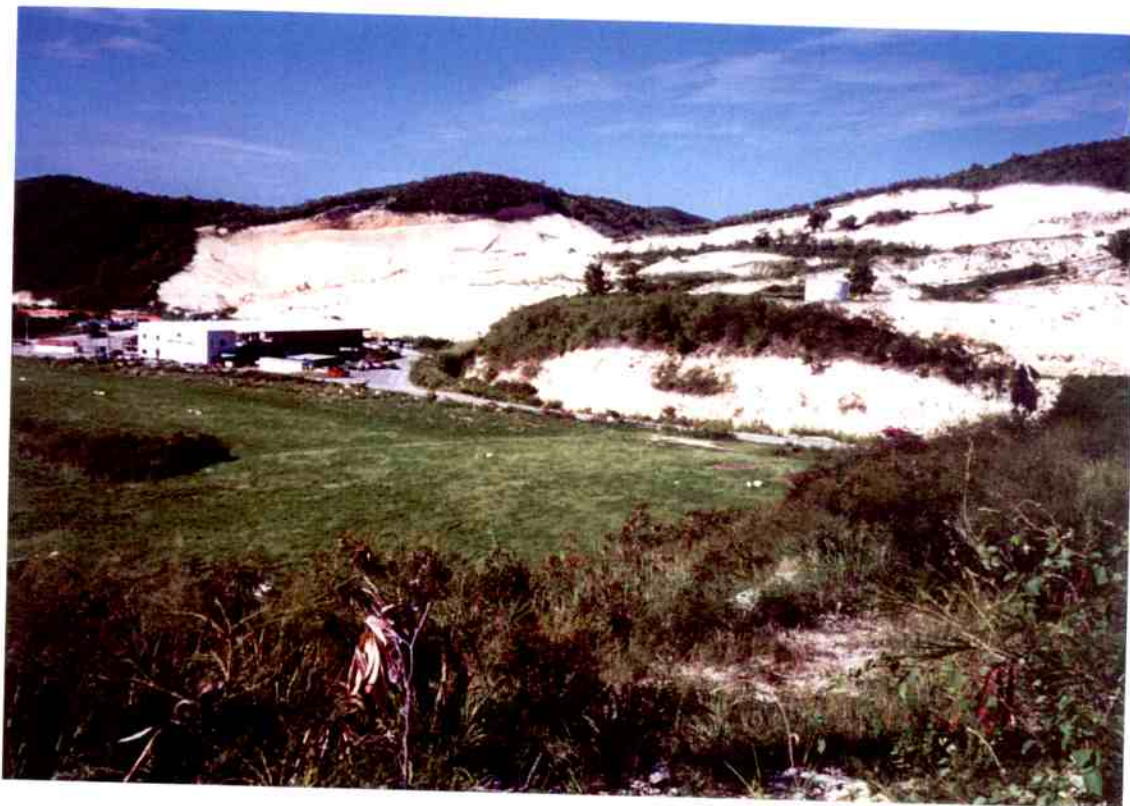
View of Top of Units 9, 10/11 & 12/16 Looking Southwest

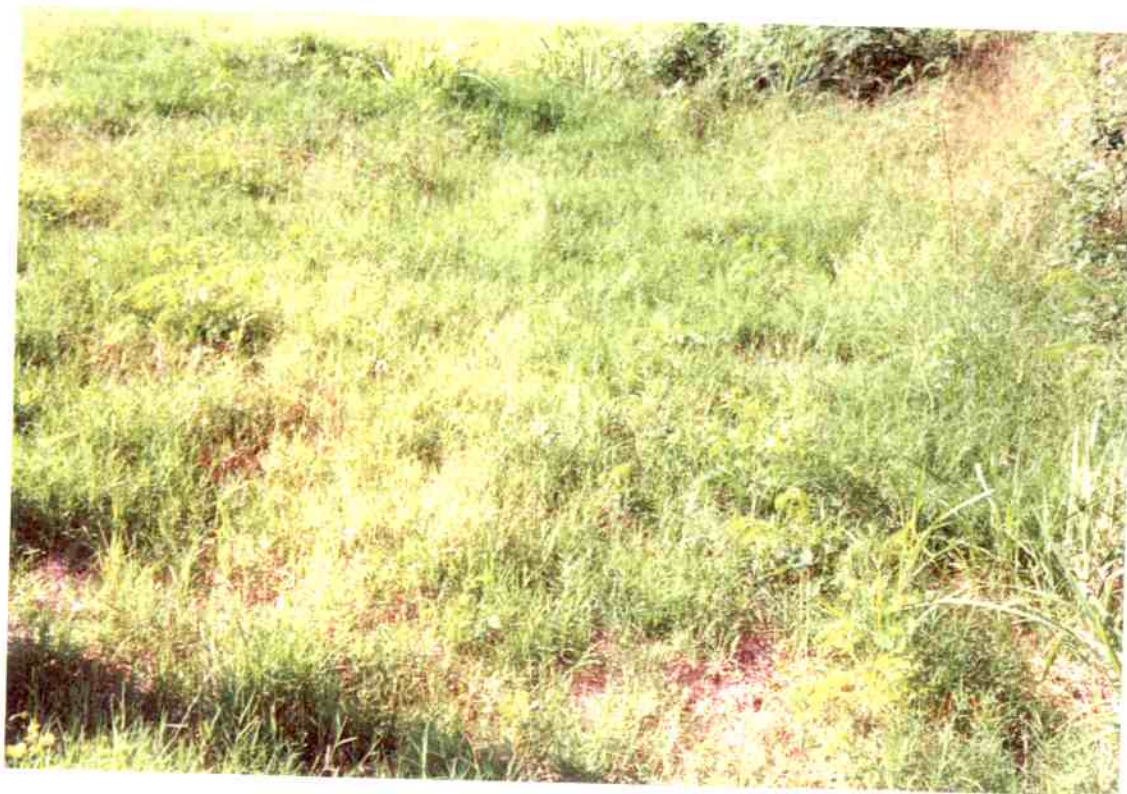
View of Vegetation on Unit 12/16

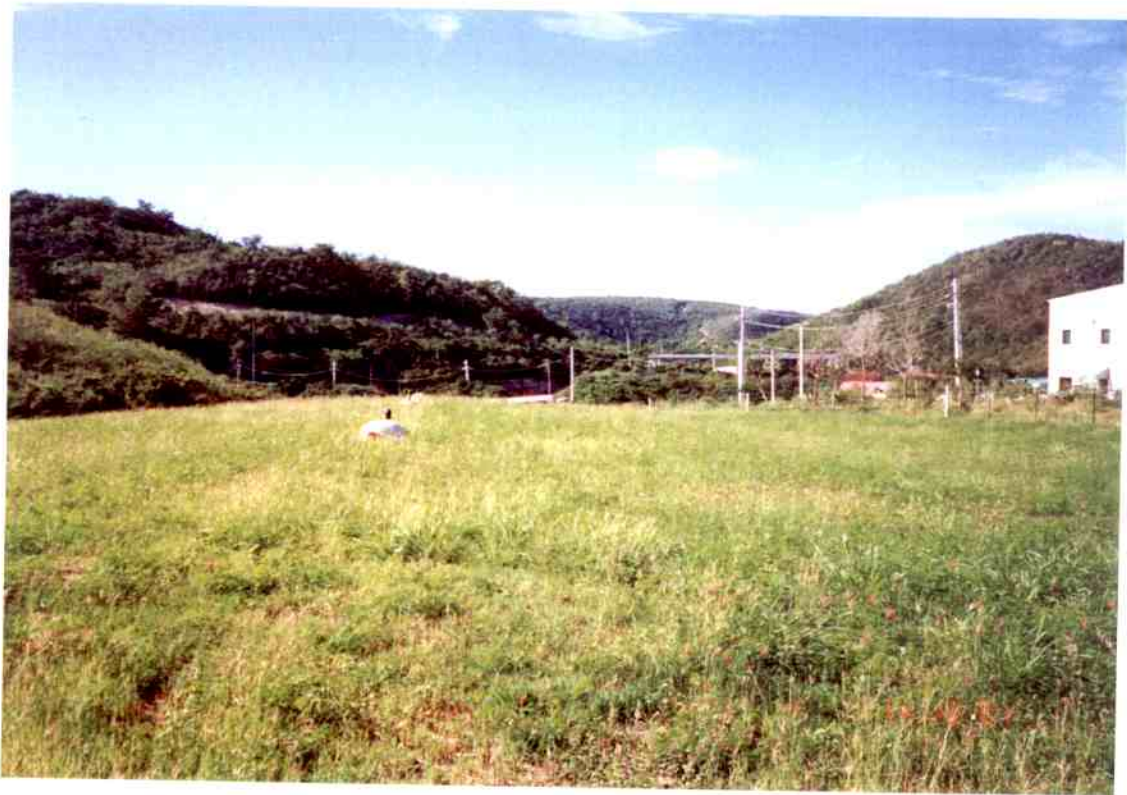
View of Unit 12/16 Looking South

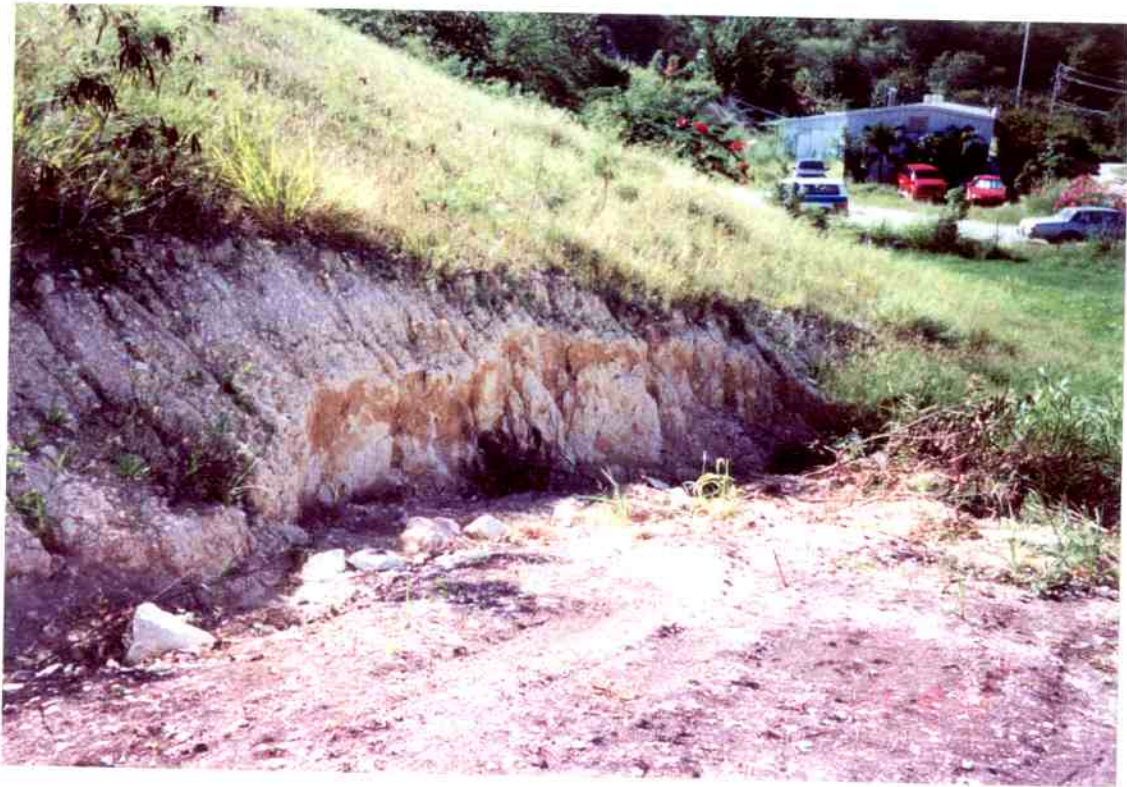
*View of Recent Maintenance Activity
(Repair of Drainage Channel Southeast of Unit 12/16)*

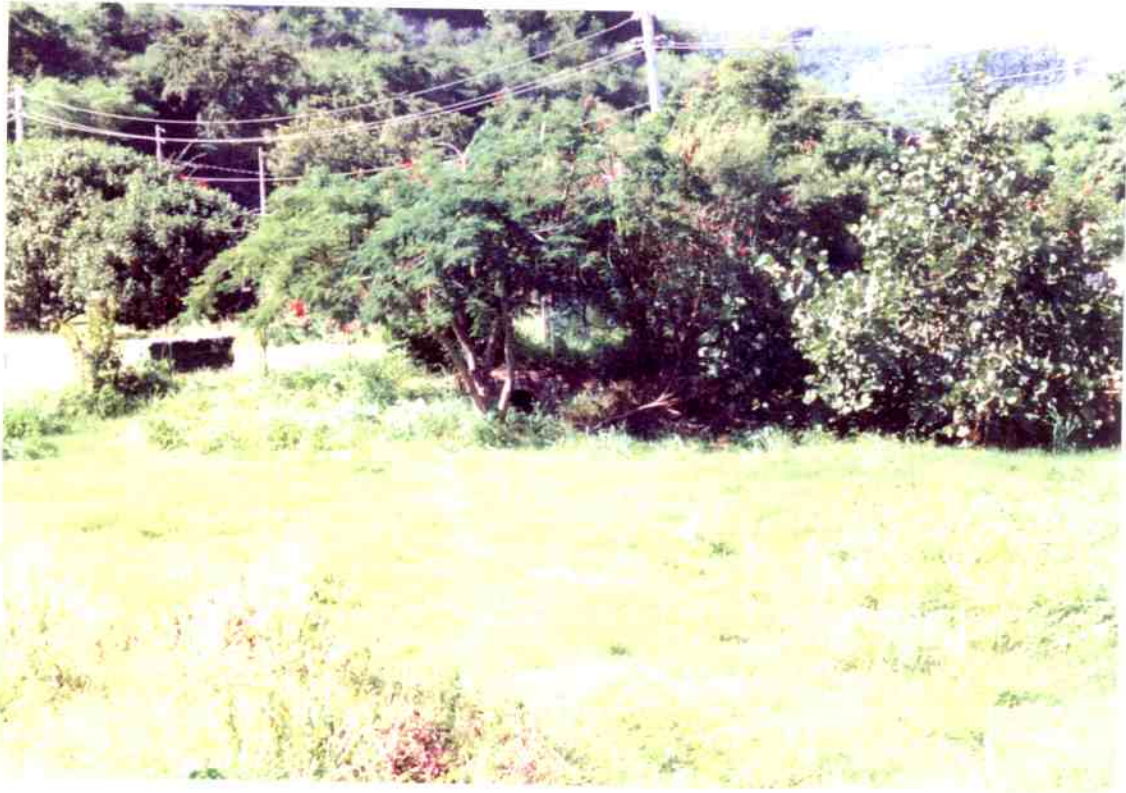
View of South Slope of Unit 12/16

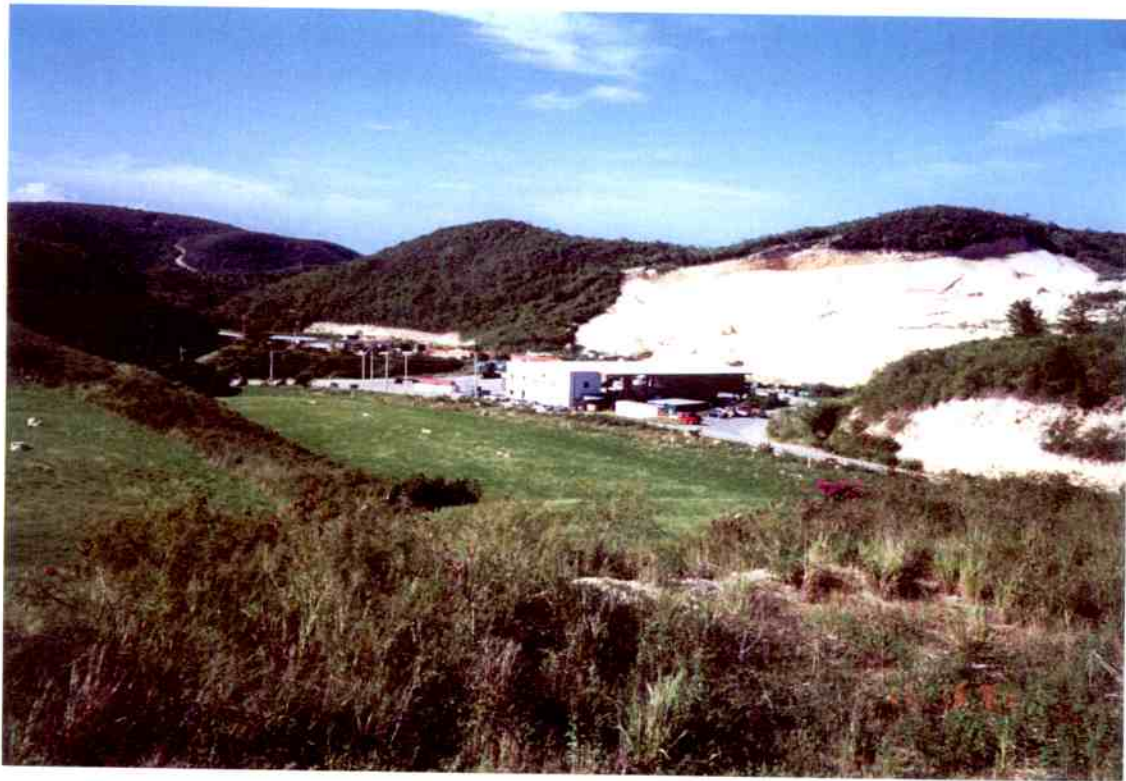
View of Top of Unit 12/16 & Portion of Unit 13 Looking Southwest

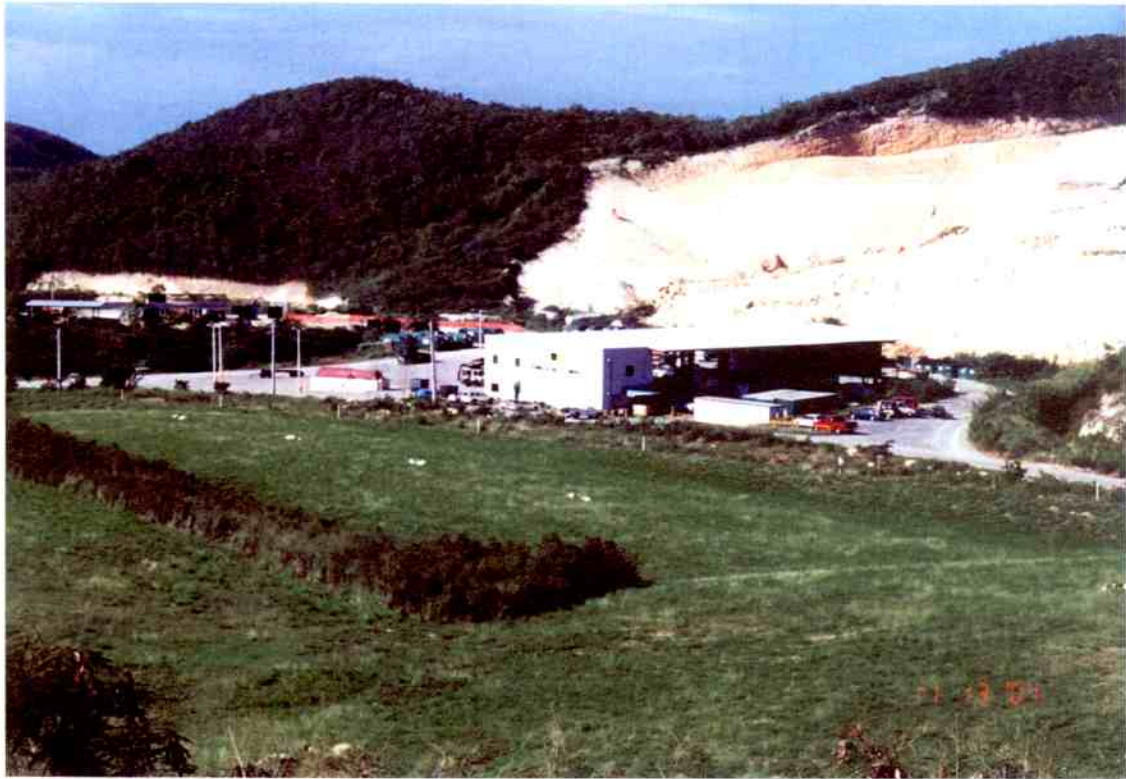
View of Top of Unit 12/16 & Portion of Units 9 & 13 Looking Southwest

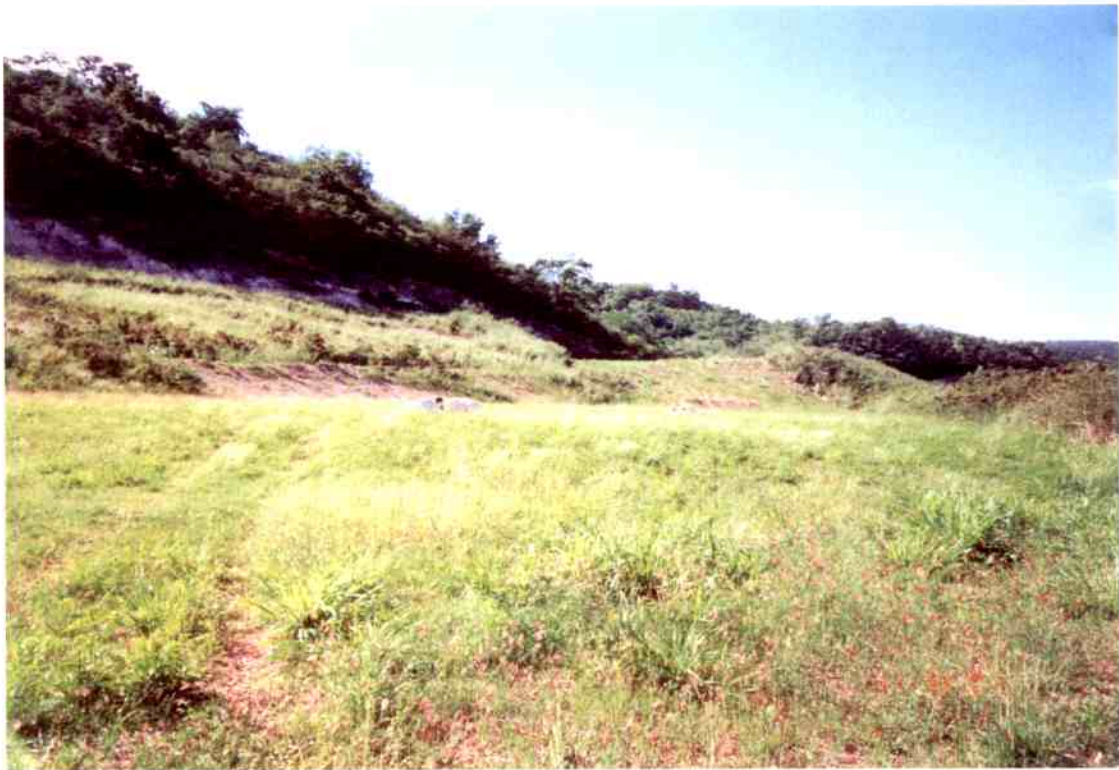
View of Top of Unit 13 Looking South

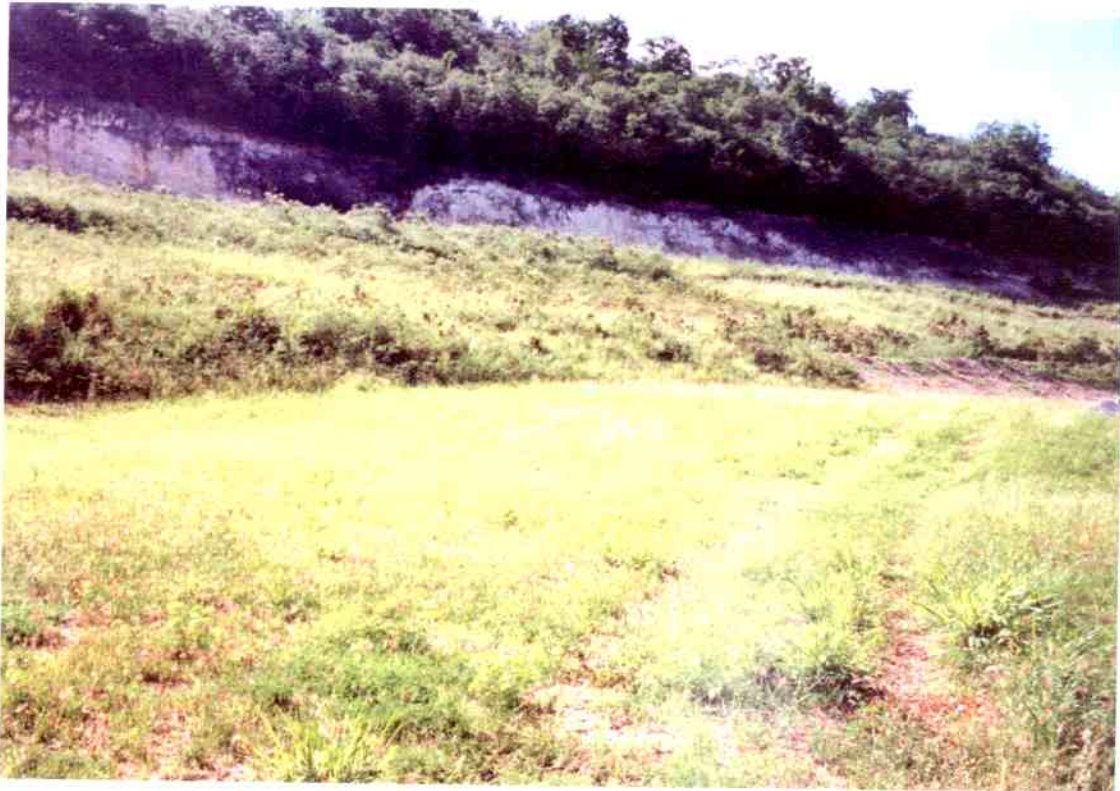
View of Top of Unit 13 Looking Southeast

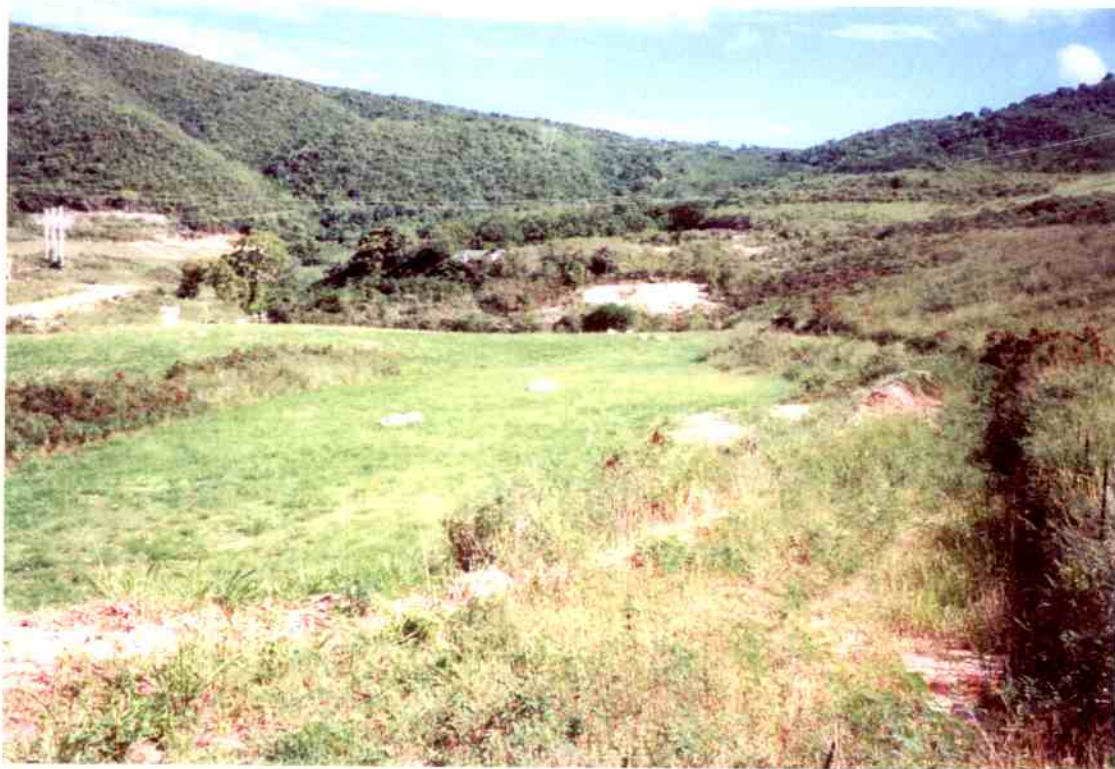
View of Top of Units 9, 10/11 & 13 Looking North from Unit 17

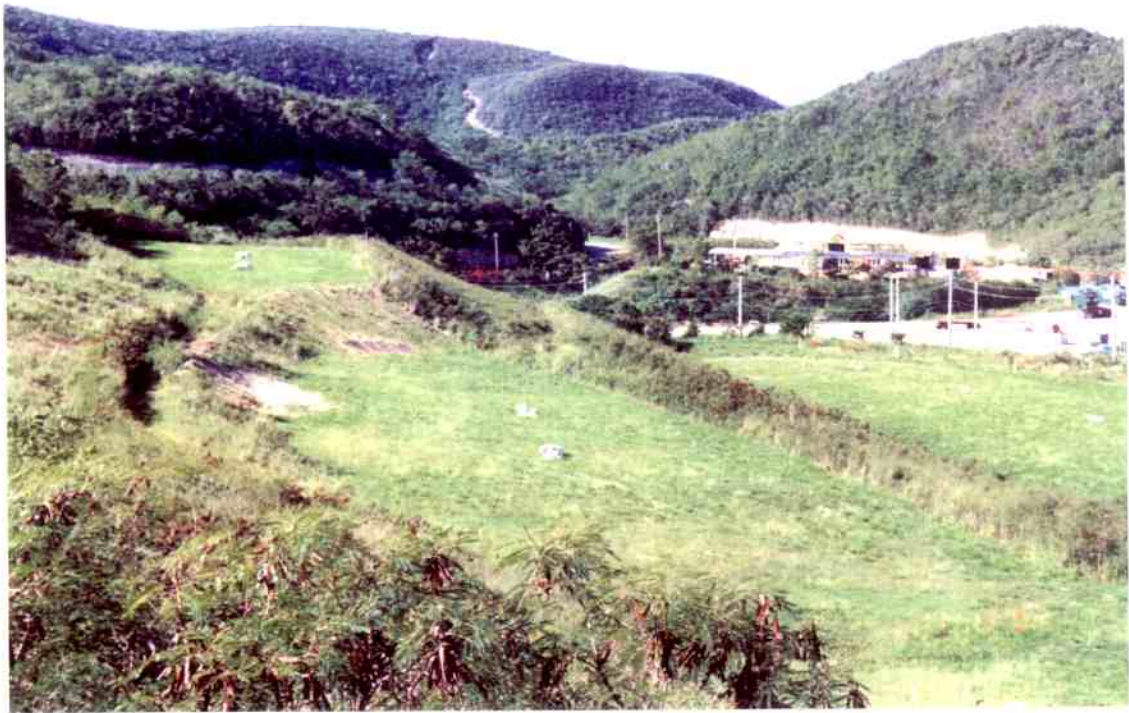
View of Top of Units 13 & 17 Looking South

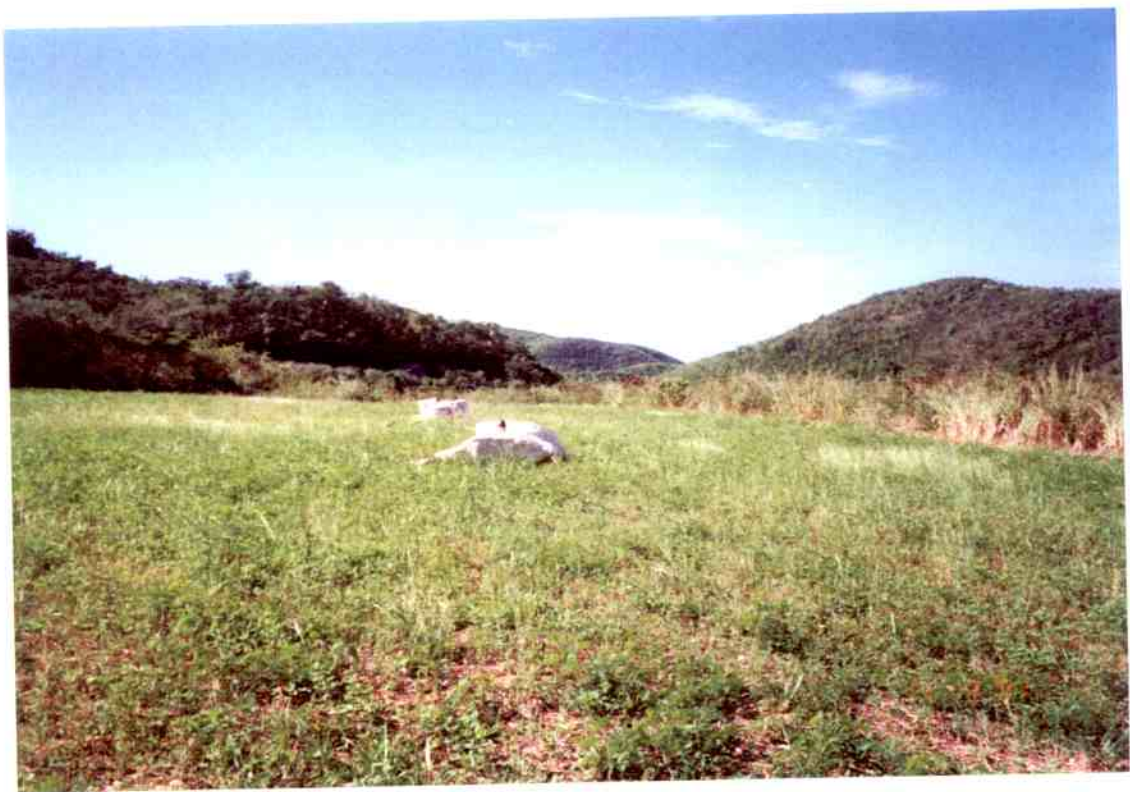
View of Top of Unit 17 Looking South

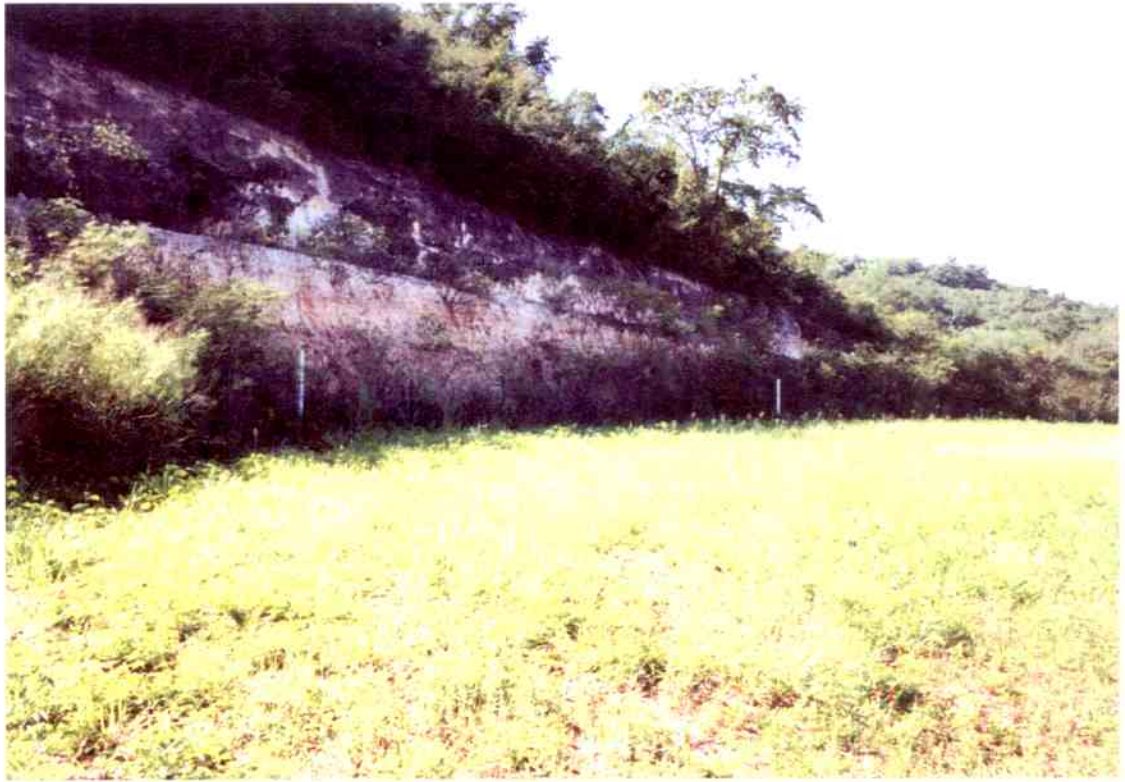
View of Top of Unit 17 Looking Southeast
